Charitable Contributions Fund Report (Q2 2024 14.2)

CONDITION AND VALUATION SURVEY

Vessel Name: SUVA
Vessel Type: Pilothouse Staysail Schooner
File No.: S581024D

Prepared for: Whidbey Island Maritime
Heritage Foundation
Date of Survey: October 22, 2024

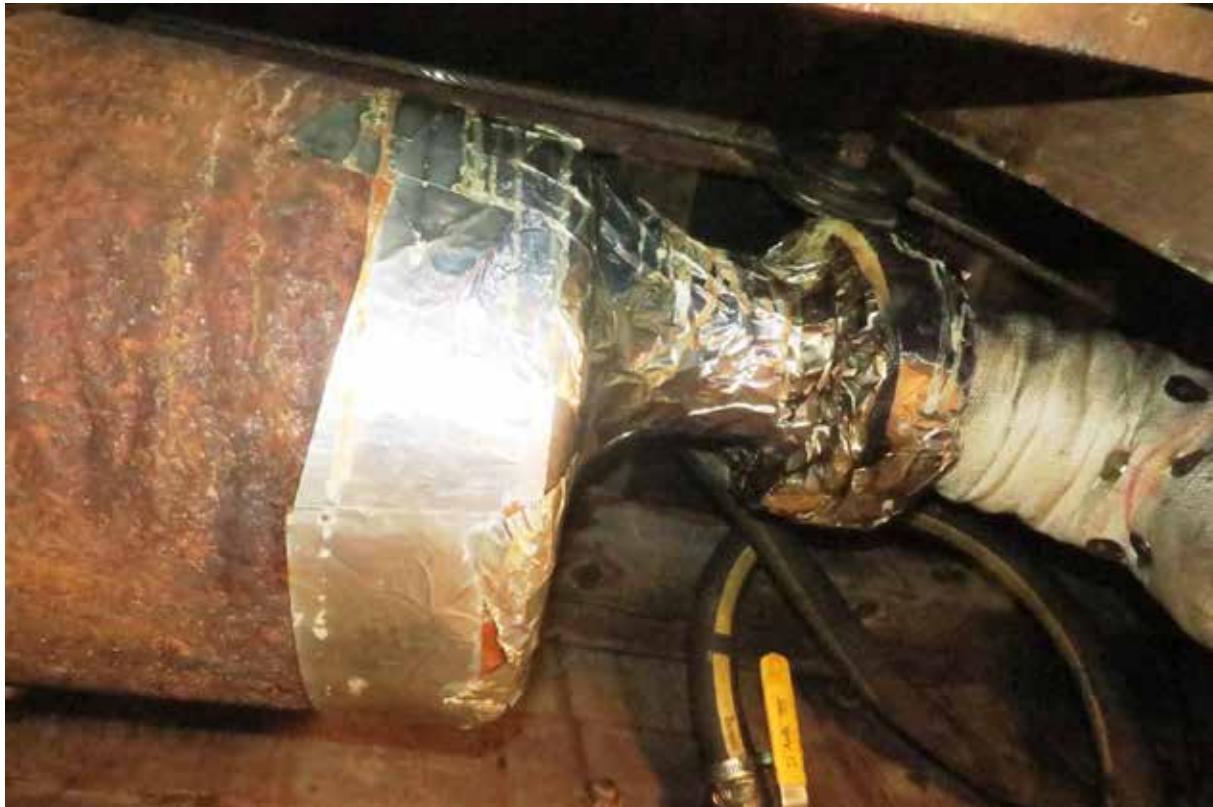
1. * The engine exhaust muffler and mixing elbow are corroded and leaking exhaust fumes into the cabin. As a result, the carbon monoxide/smoke detector has been removed from the galley.
Recommendation: Repair or replace the muffler and mixing elbow. Reinstall the carbon monoxide/smoke detector in the galley and prove operational.

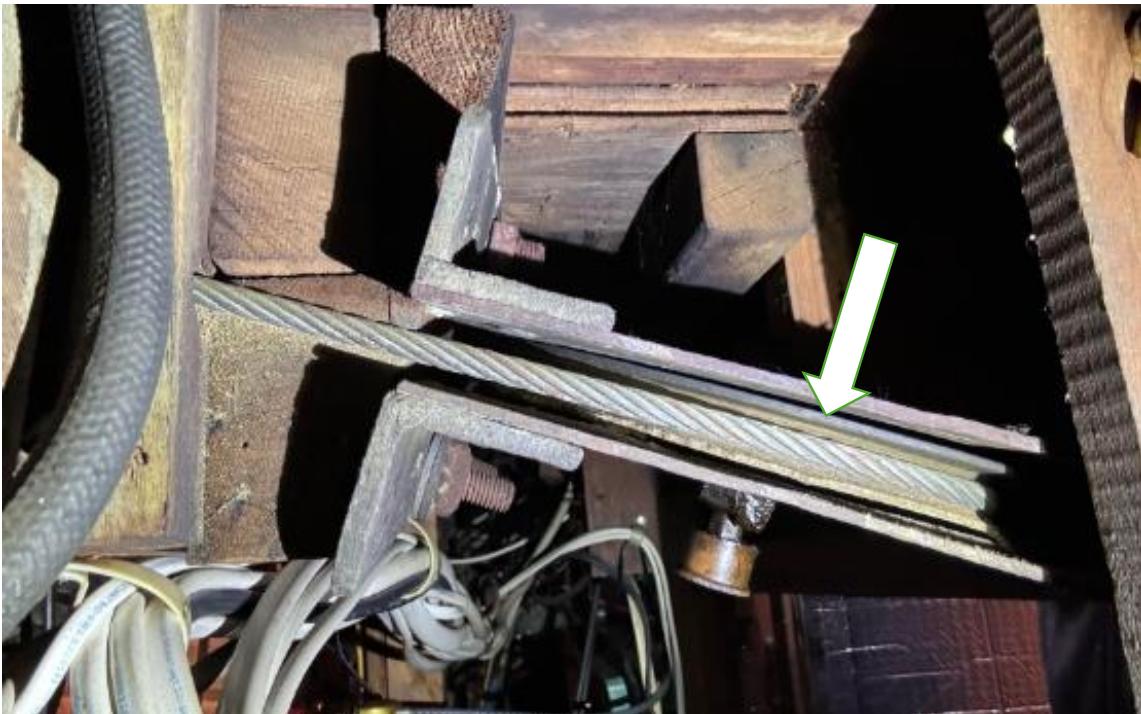
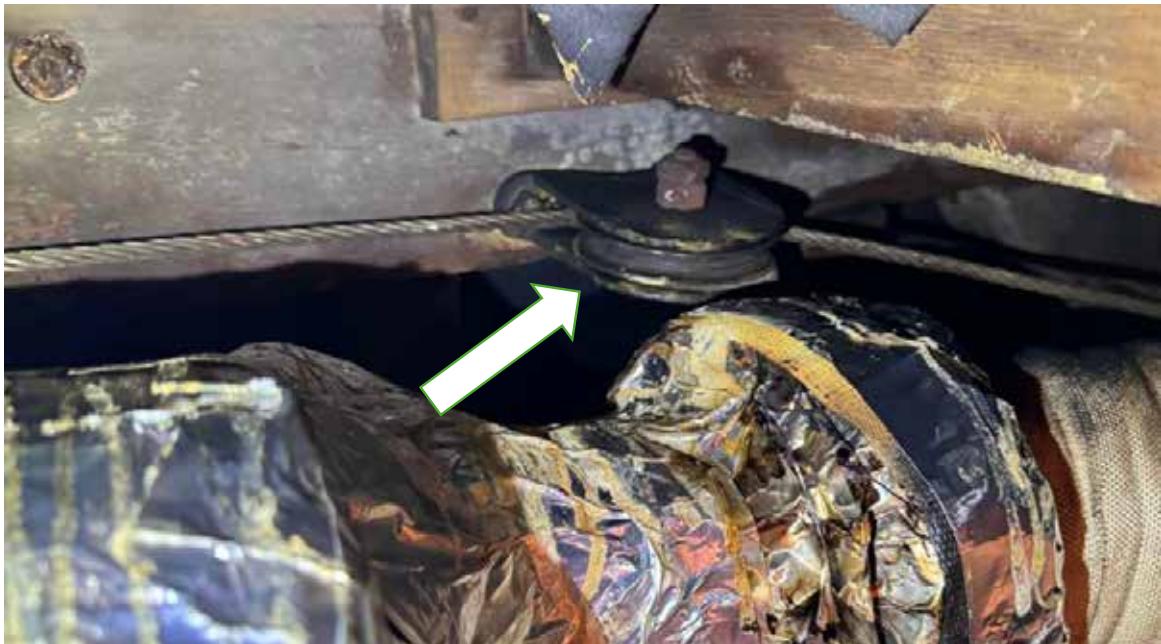
3. The starboard forward cable steering sheave is broken, and the port mid sheave is frozen.
Recommendation: Replace the broken sheave, and free up and lubricate the frozen sheave.

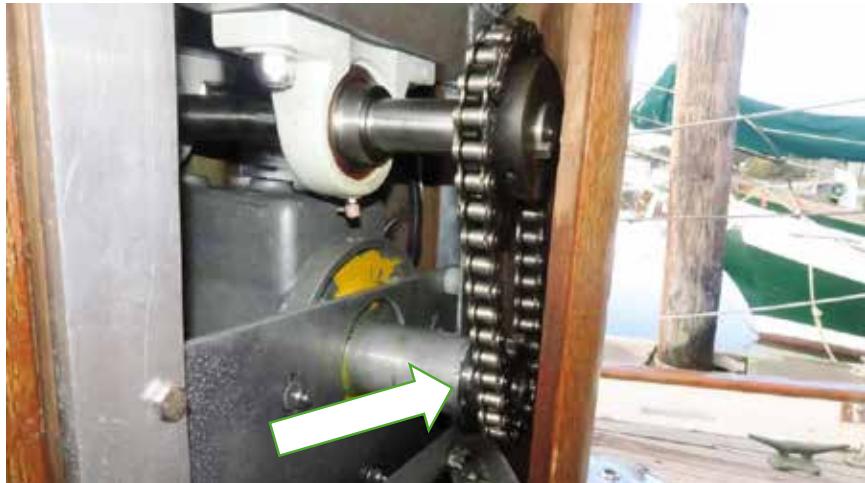
4. The hydraulic steering pump leaks oil.
Recommendation: Service to eliminate leaking.

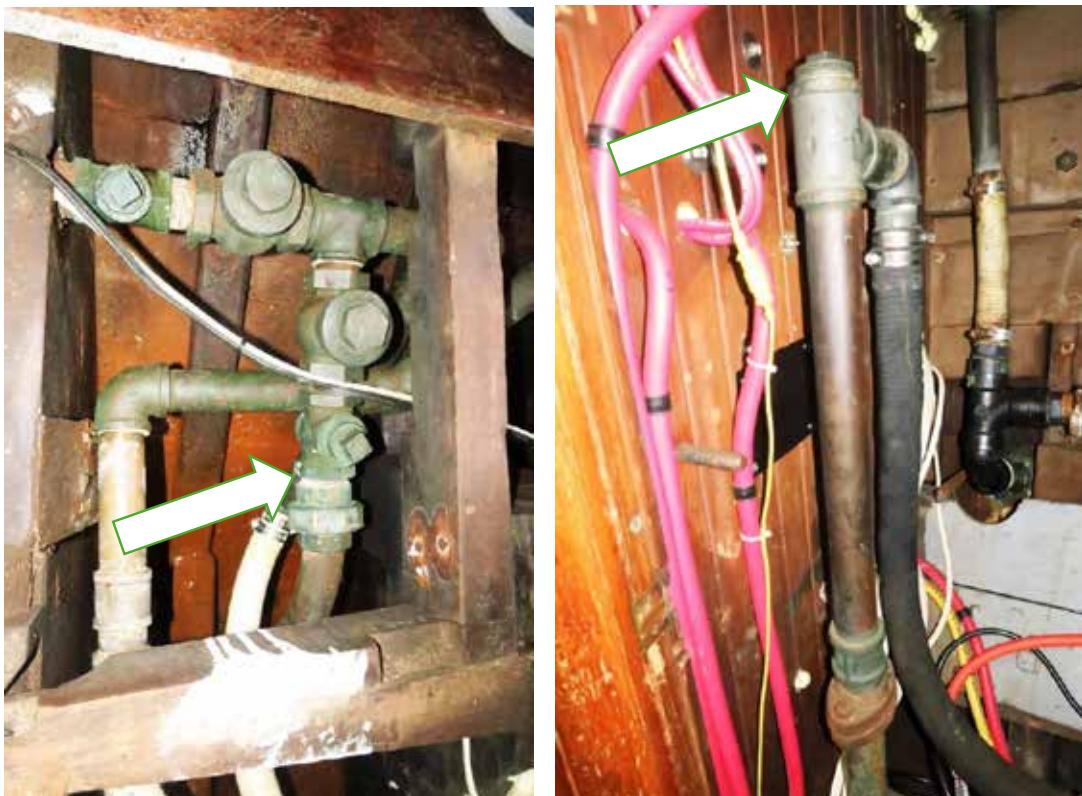
5. The engine driven bilge pump piping has a broken pipe nipple, causing the pump to suck air and not pump water. Also, the pump discharge does not include a vented loop to prevent siphoning.
Recommendation: Replace the broken pipe nipple, and add a vented loop to the discharge plumbing.

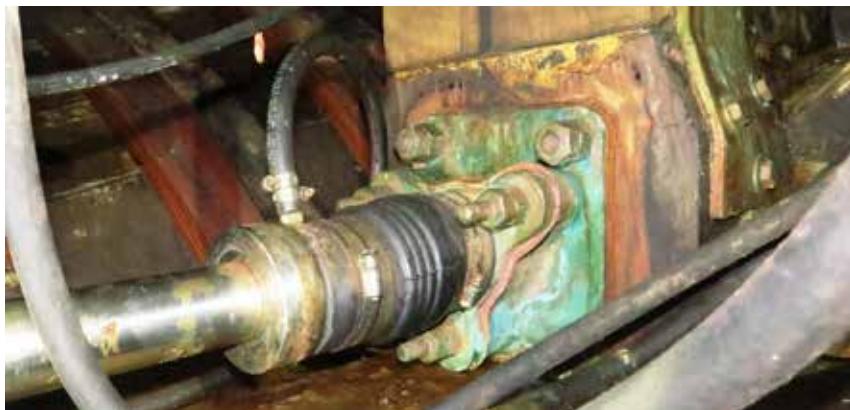
8. This vessel is fitted with a PSS shaft seal which utilizes a stainless steel ring secured to the propeller shaft with set screws. This ring must not move on the shaft, or a leak will develop.
Recommendation: It is recommended that a stainless steel hose clamp, or retaining ring be installed on the shaft against the face of the stainless rings, to prevent the chance of the ring sliding forward if the set screws do not hold or should loosen.

Also note: PYI, the manufacturer of this seal, recommends that the bellows hose be replaced every six years.

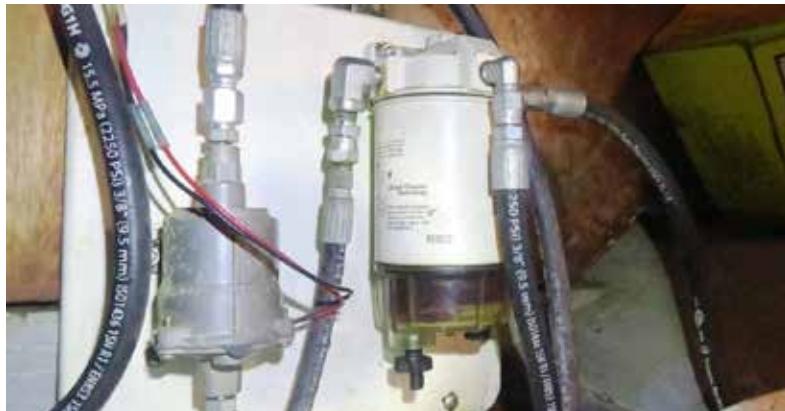
9. The diesel stove Racor fuel filter bowl is not fitted with a metal heat shield.
Recommendation: Replace the bowl with a metal bowl to meet the ABYC standard.

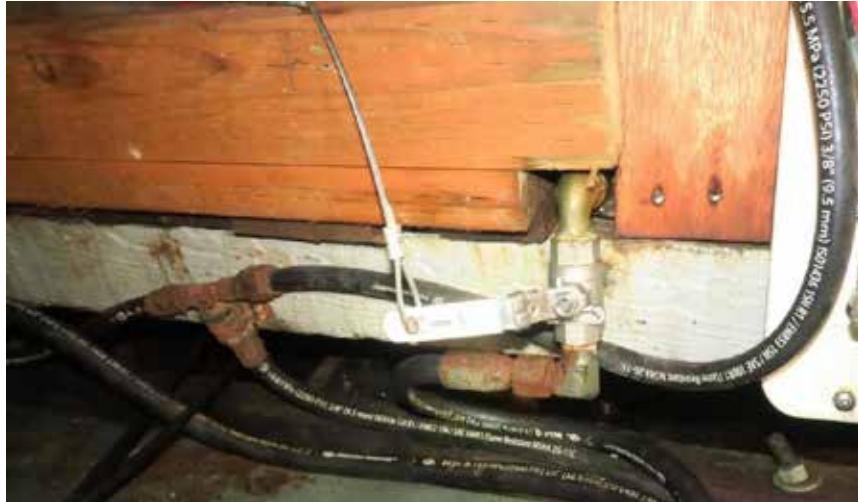
10. Some of the fuel line fittings are corroded at the aft tanks.
Recommendation: Replace the fuel lines with corroded fittings.

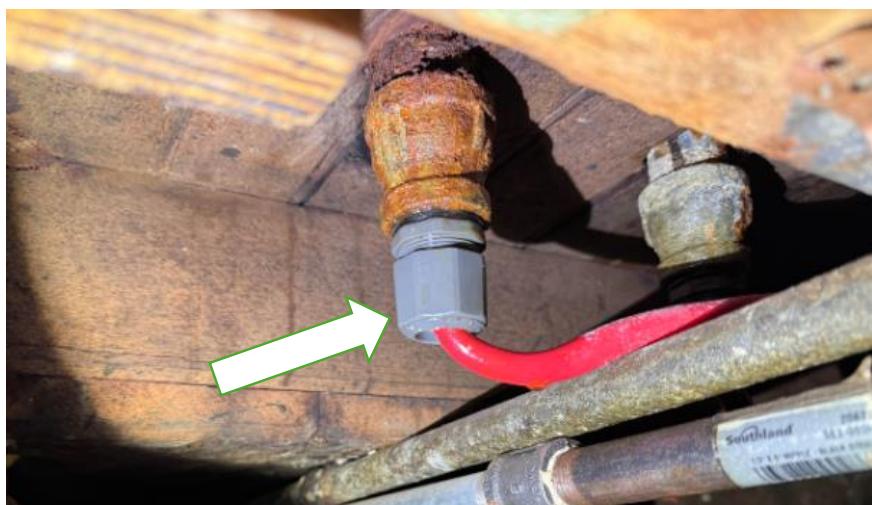
13. There is oil leaking from the windlass positive cable connection.
Recommendation: Plan to repair windlass oil leak.

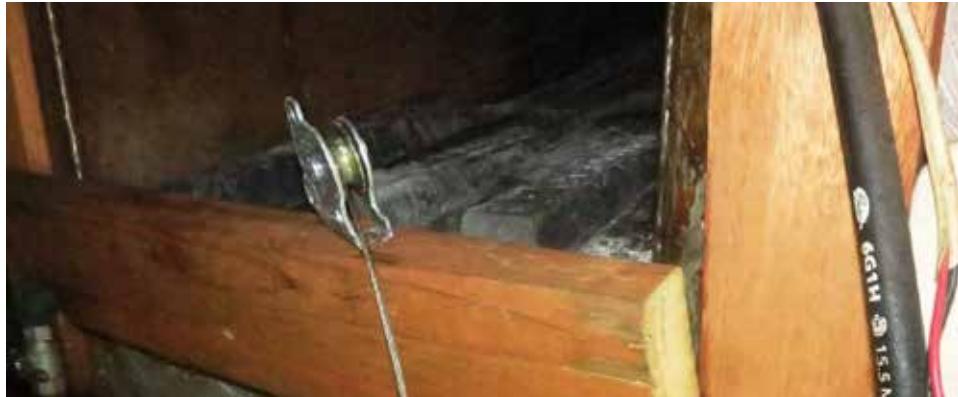
15. There is unsecured lead ballast in the hull aft of the engine.

Recommendation: Secure this lead ballast.

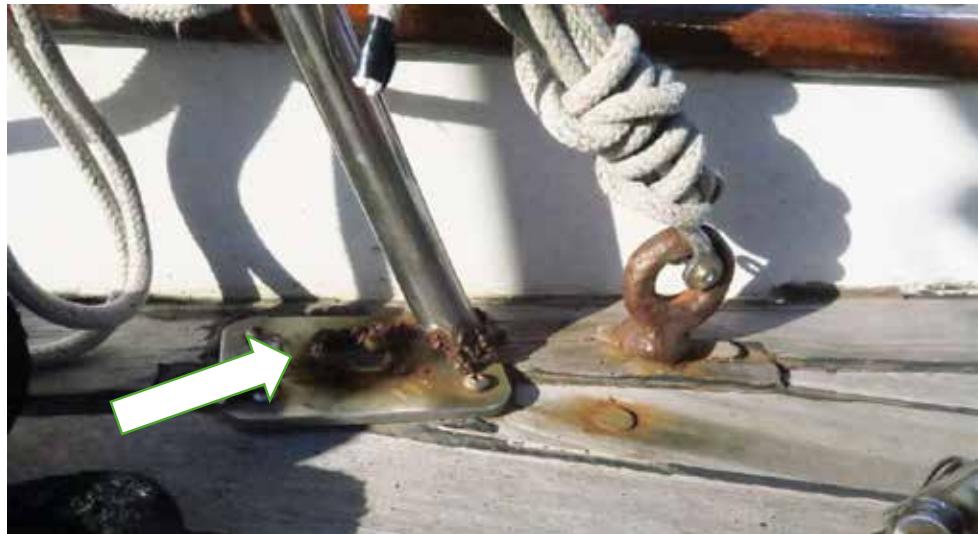
16. There is a broken weld on a pushpit mounting pad.

Recommendation: Reweld mounting pad.

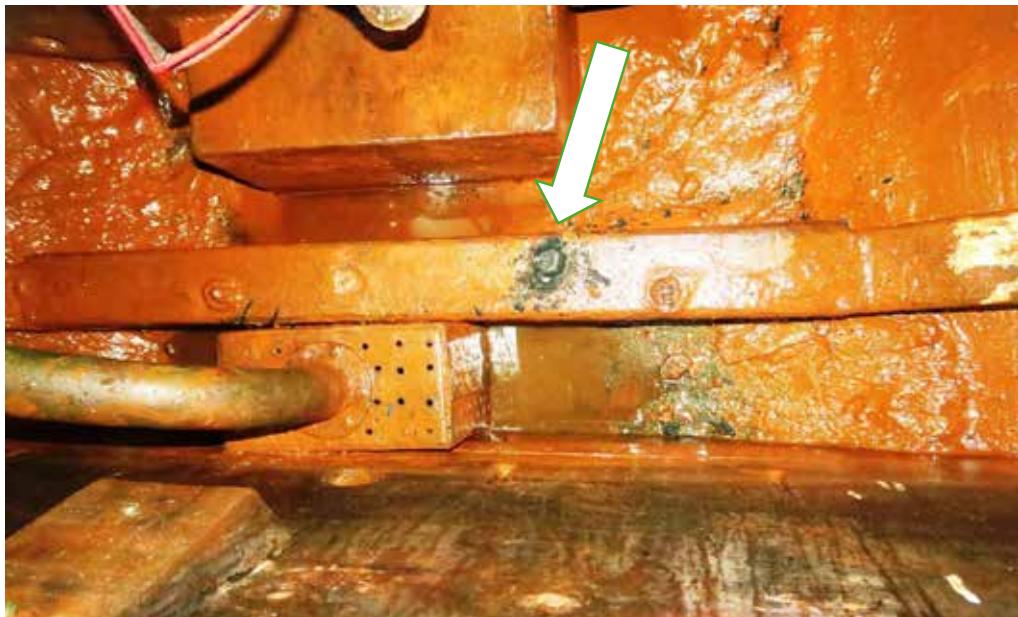
19. Some of the original bolts securing the floor timbers to the frames are corroded in the galley bilge (see sample photo below, with arrow indicating corroded bolt), but appeared to be in better condition further forward.

Recommendation: Plan to re-fasten the floor timbers to the frames as needed.

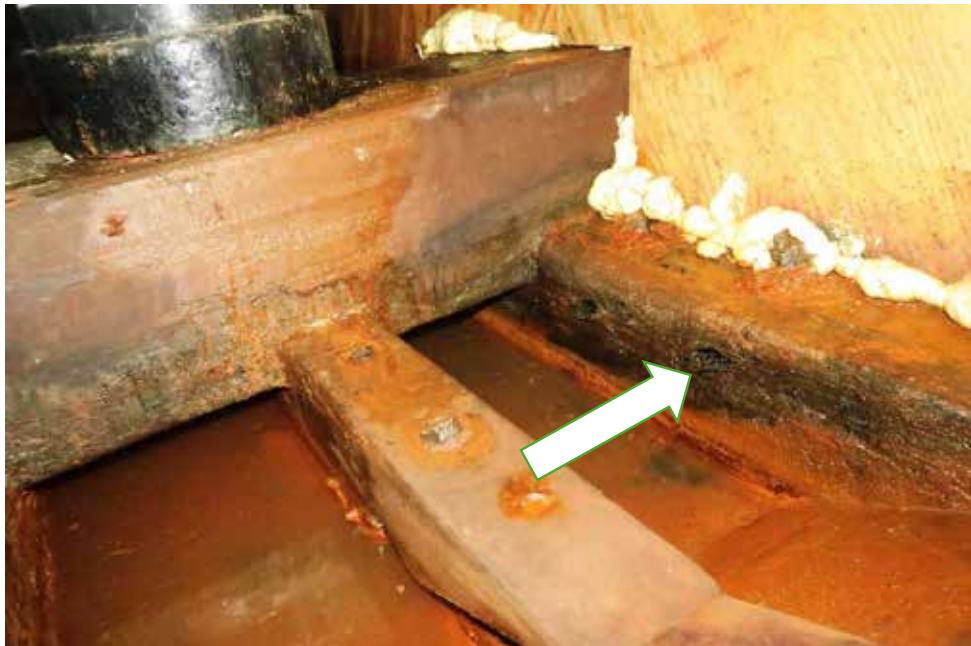
20. Some soft wood was noted in a floor timber supporting the main mast step.

Recommendation: Plan to replace the soft wood and restore the floor timber to original integrity.

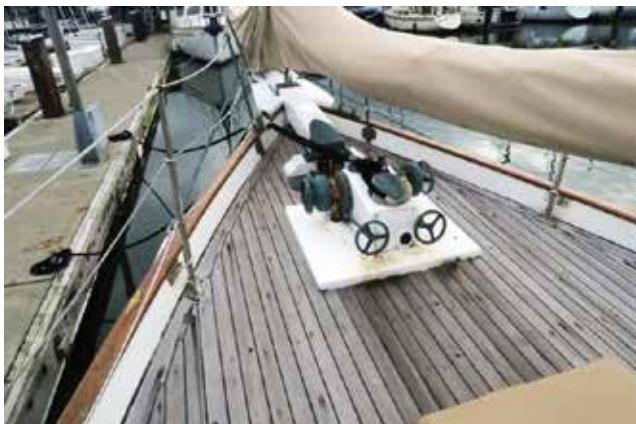
Windlass	Ideal 12VDC horizontal type with twin chain wheels and capstains	Functional, seeping oil at DC cabling
Anchors	Primary: 150# Navy Stockless Secondary: 200# Danforth	Galvanized Galvanized
Rodes	3/8" galvanized chain: 270' & 328' lengths reported	Good condition, not fully inspected,

Ideal Windlass and bow

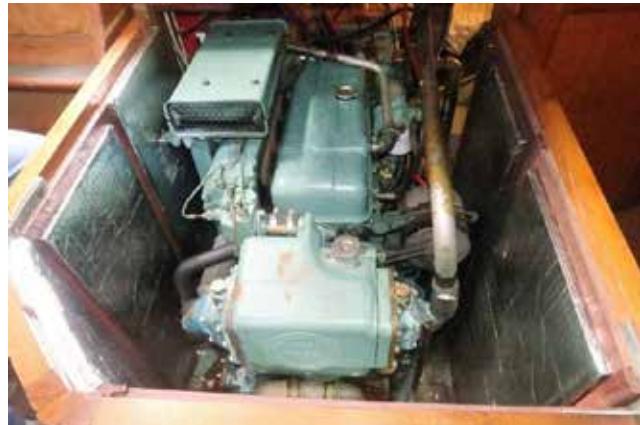
Engine make and model	Detroit Diesel 5042-4000	The engine was run dockside. Oil leaks noted, but otherwise ran normally. Eventual replacement is planned.
Serial Number	4D-38979	
Rated power	107 HP @ 2400 RPM	
Indicated hours	4274	
Cooling	Fresh water with raw water heat exchanger	Functional
Exhaust	Wet exhaust with waterlift muffler	Elbow/muffler corroded and leaking
Controls	Mechanical cables	Functional

Detroit Diesel engine
